# **Oil Circuit Pressurizing Procedure**

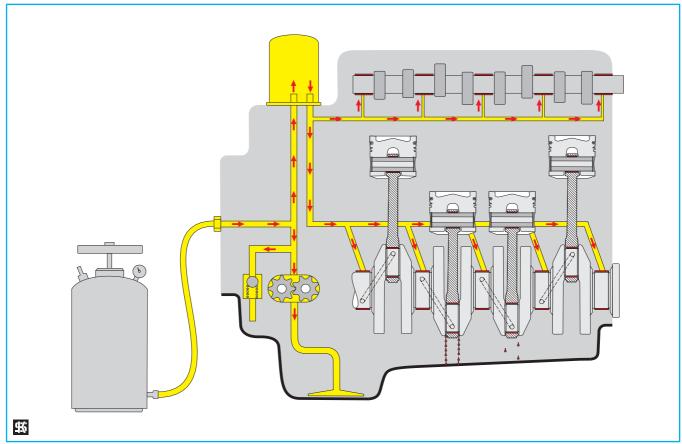
Fig. 1

- 1. With the assistance of a pressure tank, at least 30% of the normal engine oil capacity is pumped into the engine through a threaded connection in the oil pressure system (Figures 1 and 2). The screw plugs provided by the engine manufacturer are the most suitable connection points for this purpose. If no such plugs are available, a plug can be removed from an oil hole or an oil pressure switch to make the connection, if necessary.
